# BLUENOSE II Rebuild Project – FAQ

## Hogging of Bluenose II 1963 to 2009

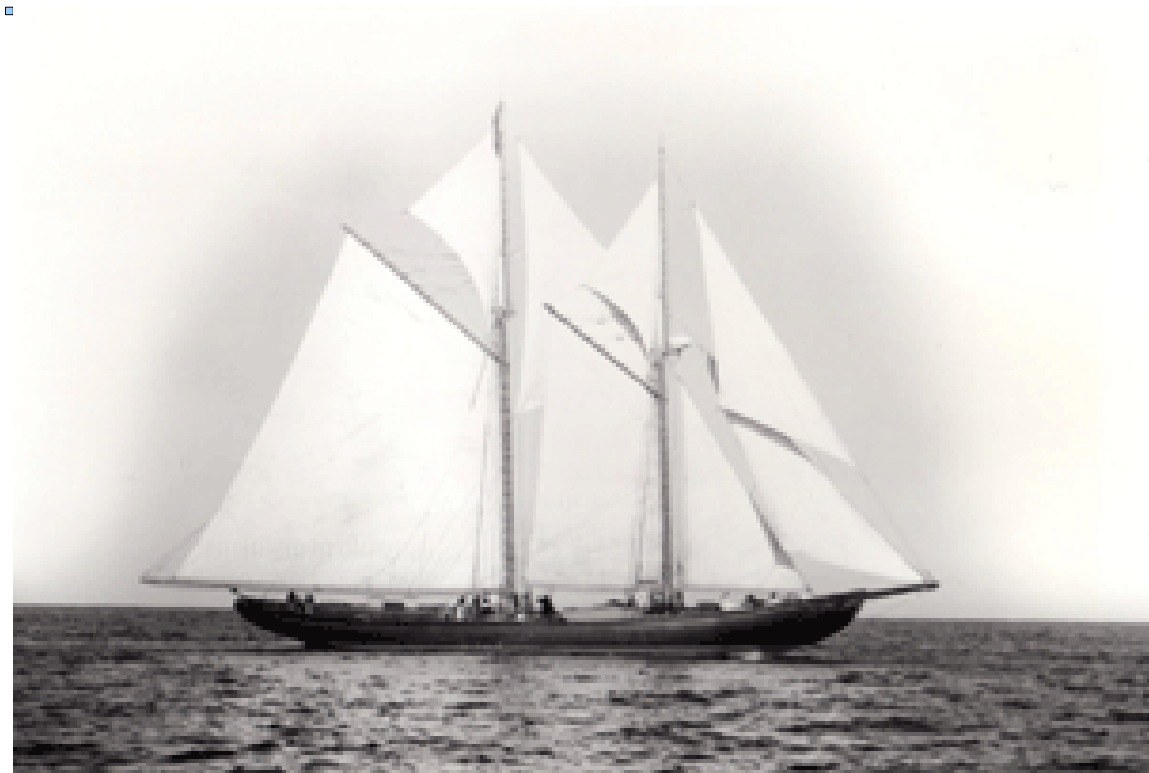
The banana shaped hull in 1963. Notice the space under the stern.

A. A ship floating quietly in still water is subjected to external forces. These are the weight of the vessel (downwards) and the buoyancy force (upwards). For a floating rectangular piece of wood, they are also equal in distribution. For most normally shaped ships, the distribution is not equal. For example, when an empty ship has more weight (relatively heavy structure, engines and equipment) in the ends, and more buoyancy in the middle. This "excess" of buoyancy in the middle causes the middle to rise up and the ends to bend down -- a hog in profile. See images illustrating hogging of Bluenose II from 1963 to 2009 at the end of this FAQ.

A. The last measurement taken in 2009 had shown the aft end of the vessel had dropped by 3+ feet.

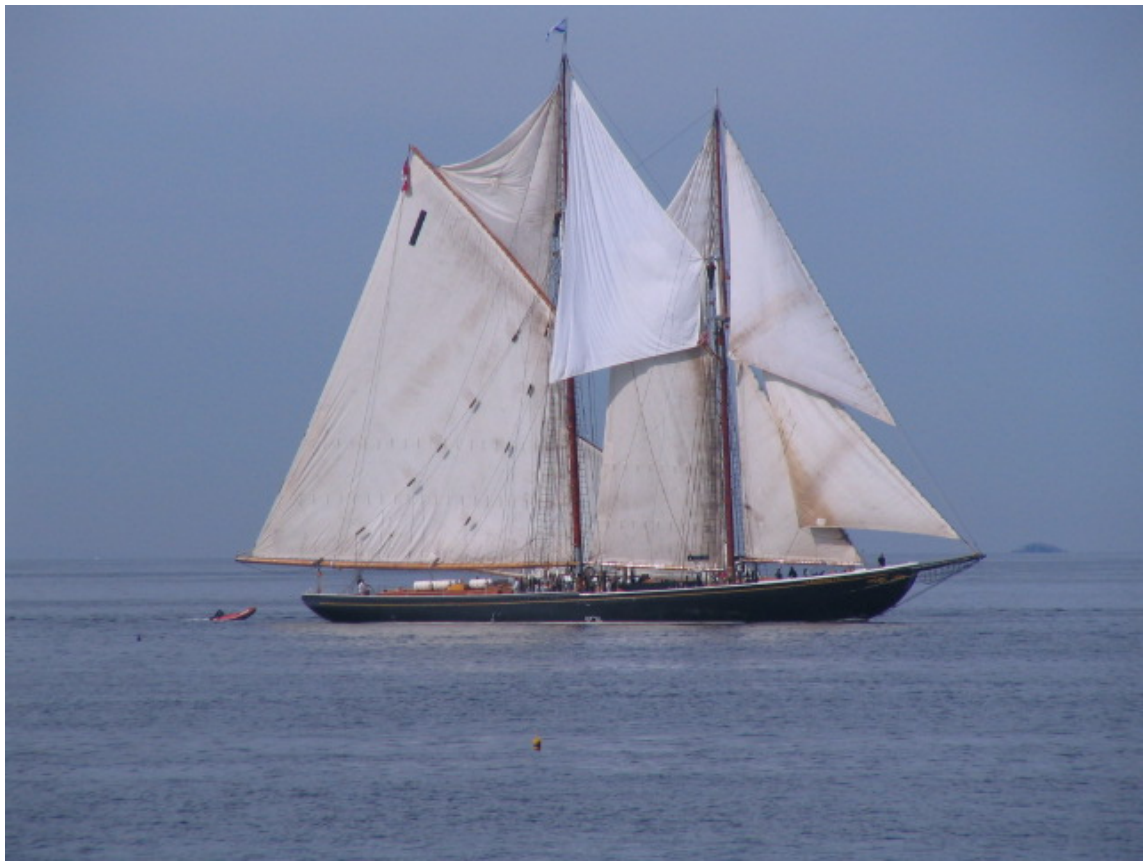
The following image clearly shows the results of 46 years of hogging.

By 2009 the hull has “hogged”. The stern is down by 3-1/2 feet and in the water.

The bow not as much but quite noticeable.
